ROCK STRIKE TESTING OF TRANSPARENT ARMOR NLE-01

David N. Hansen, Ph.D.
Ashley Wagner

12. DISTRIBUTION/AVAILABILITY STATEMENT Approved for public release, distribution unlimited					
13. SUPPLEMENTARY NOTES Presented at 20th U.S. Army Ground Vehicle Survivability Symposium, U.S. Army Tank-Automotive and Armaments Command Research, Development, and Engineering Center, (TARDEC), Warren, MI, USA, 18-19 August 2010, The original document contains color images.

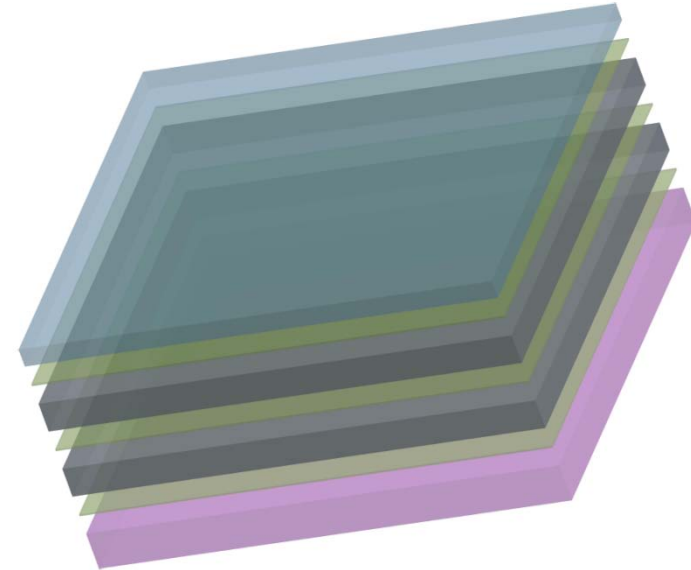
4 X 4 GLASS CERAMIC

1	0.388"	Glass ceramic
2	0.025"	Urethane Interlayer Huntsman PE 399
3	0.388"	Annealed water white clear glass
4	0.025"	Urethane Interlayer Huntsman PE 399
5	0.388"	Annealed water white clear glass
6	0.025"	Urethane Interlayer Huntsman PE 399
7	0.388"	Annealed water white clear glass

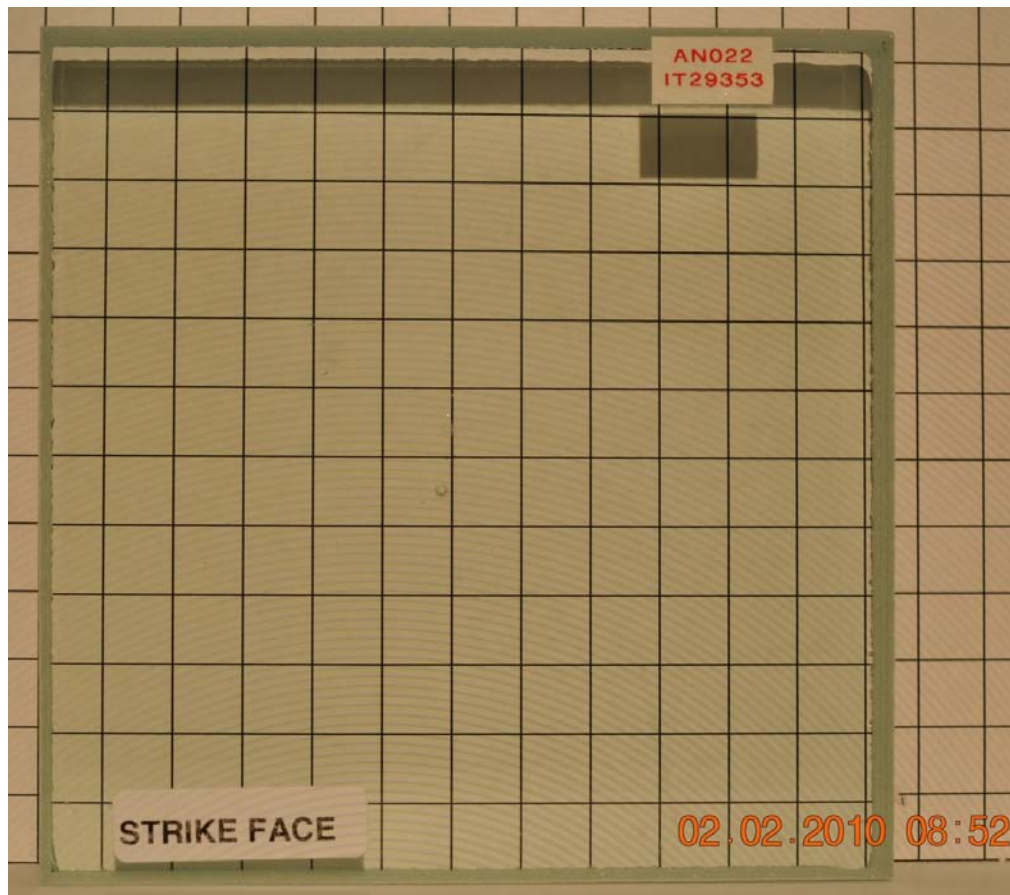
AN022 12mm BALL AT 135 f/s, RANKED 1

VARIABILITY OF CRACK RESPONSE WHERE ALL OF THE STRIKING PROJECTILES WERE VERY SIMILAR AND THE STRIKING SPEEDS WERE WITHIN 3 f/s OF 132 f/s.

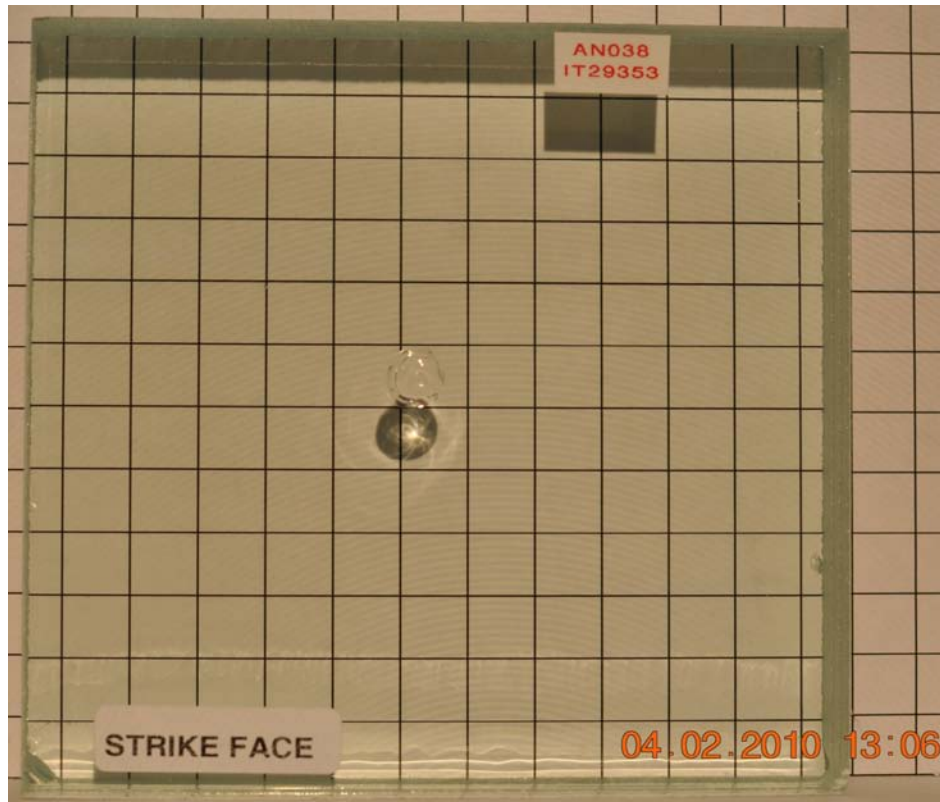
AN038 12mm BALL AT 129 f/s, RANKED 3

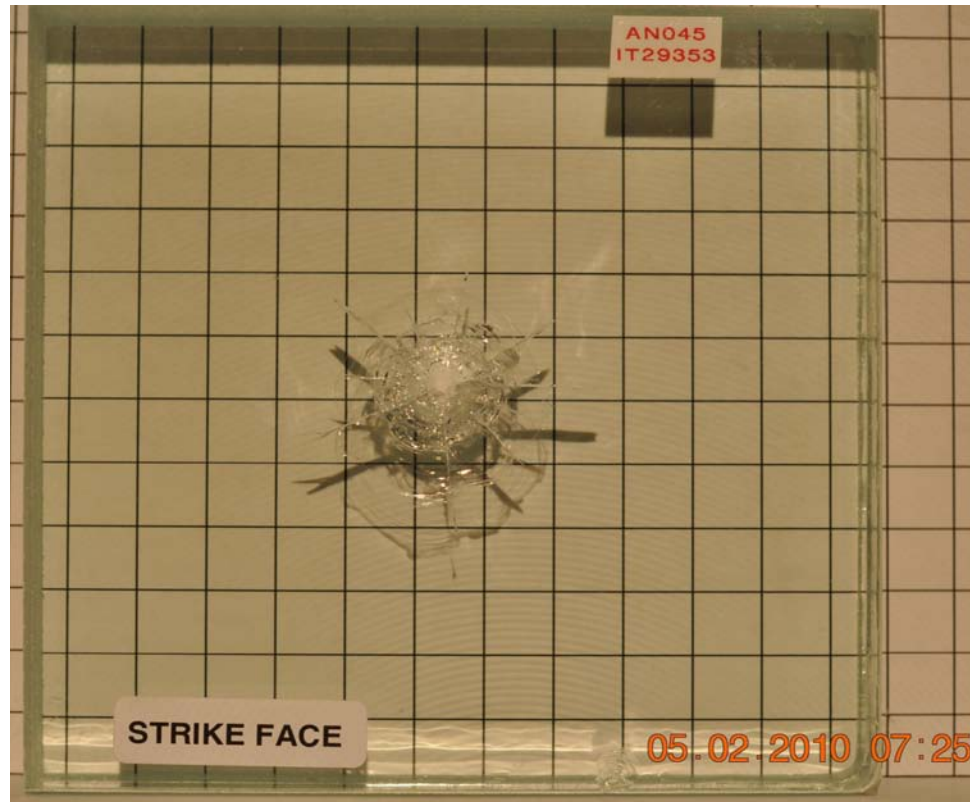
AN045 12mm BALL AT 133 f/s, RANKED 5

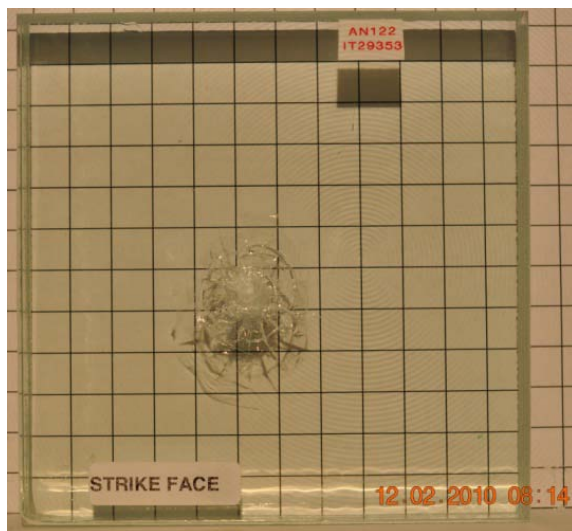
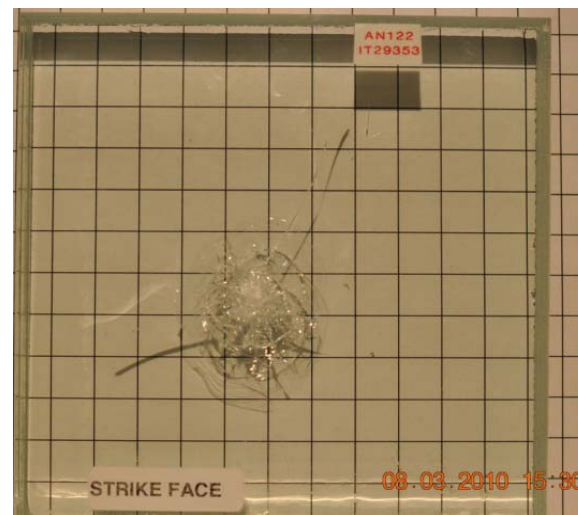
CRACK EXTENSION

MEASURE CRACKS BEFORE AND AFTER

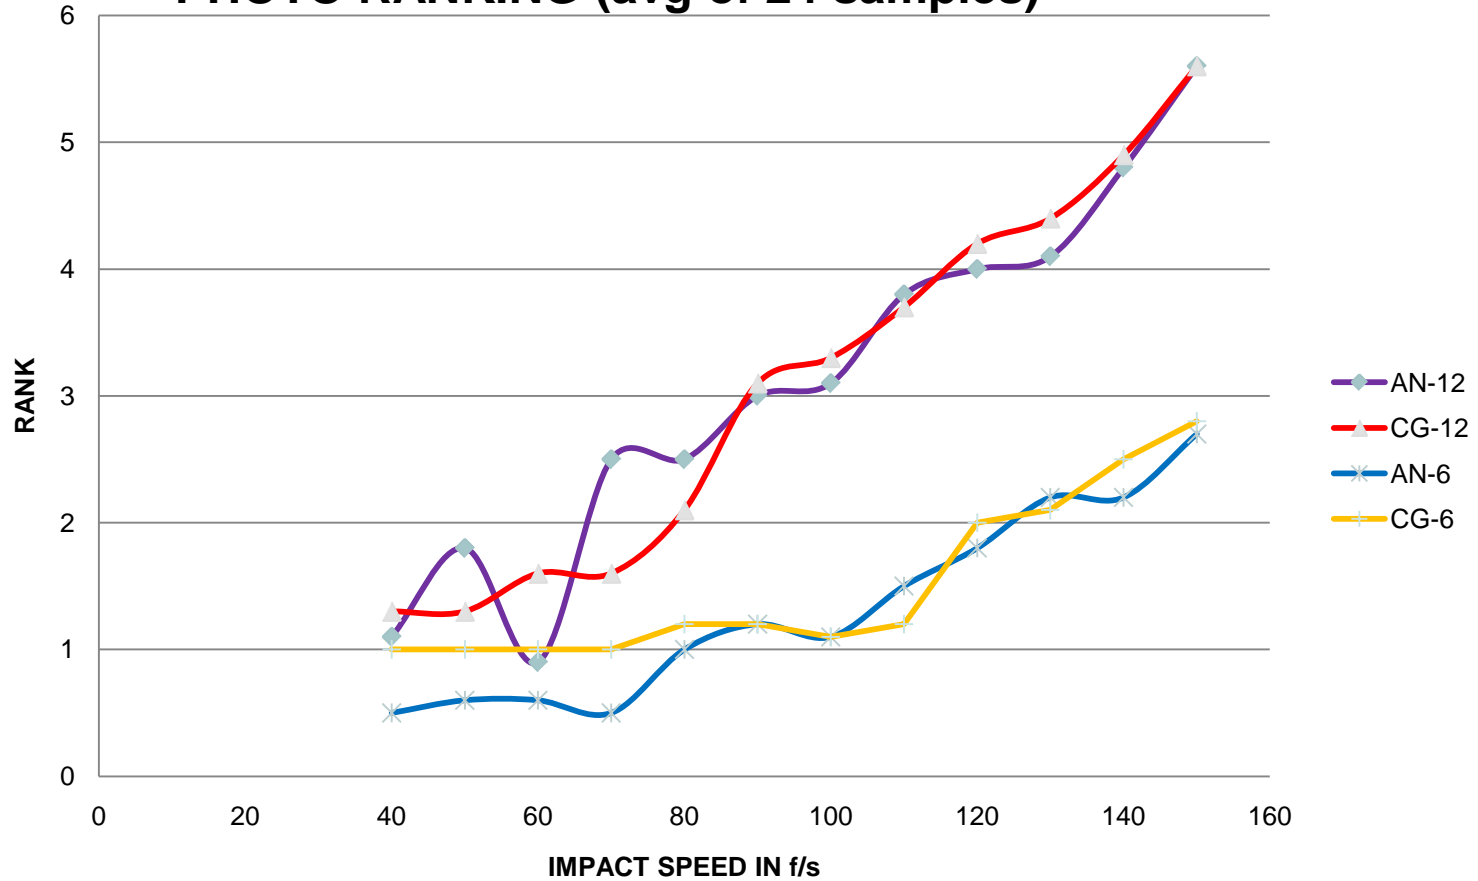
Damage Descriptions and Rank			Attributes
Light Crush or Ring with no Crush	CRS	1	Often only seen as a shadow and less than quarter inch diameter.
Small Circular Crack	SCC	2	About quarter inch diameter with or without small radial cracks
Circular Crack	NCC	3	Greater than about 3/8" and less than 1 1/4" diameter, some small radial cracks may be present
Large Circular Crack with or without Crush	LCC	4	Greater than about 1" with no radial cracks greater than circular crack diameter
Large Circular Crack with Radial Cracks	LCR	5	Radial cracks not much larger than largest circular crack.
Large Circular, Radial, Crush, Failures	LCRC	6	Numerous radial cracks not much larger than about 150% of largest circular crack and crush apparent.
Radial Cracks to Edge	RCE	7	Three radial cracks extending 2 or more inches or to the edge of the coupon.

PHOTO RANKING (avg of 24 samples)

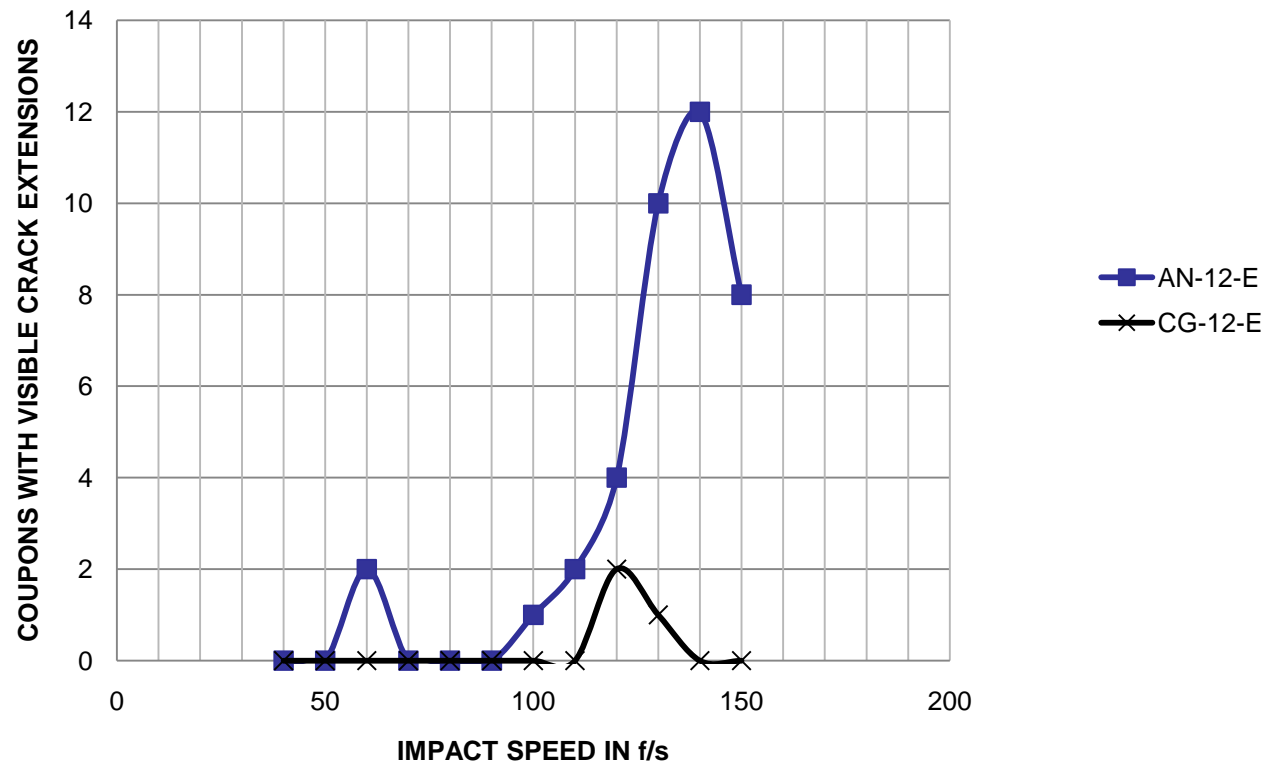
THERMAL SHOCK INDUCED CRACK EXTENSIONS
